Warlpeyangkrere flooring project

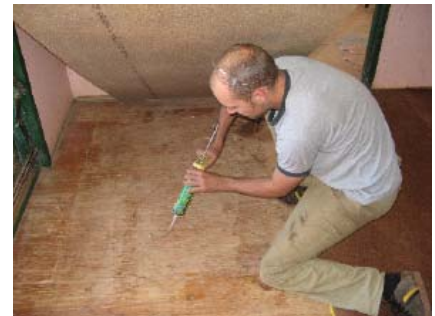
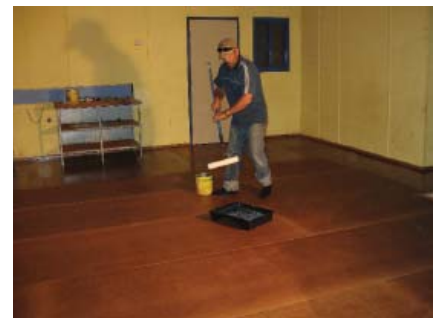
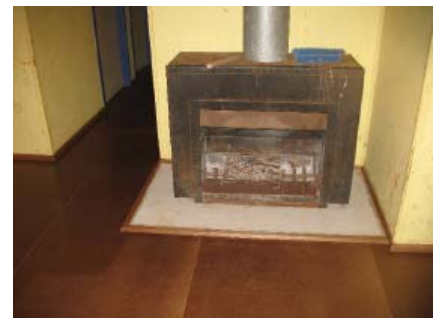
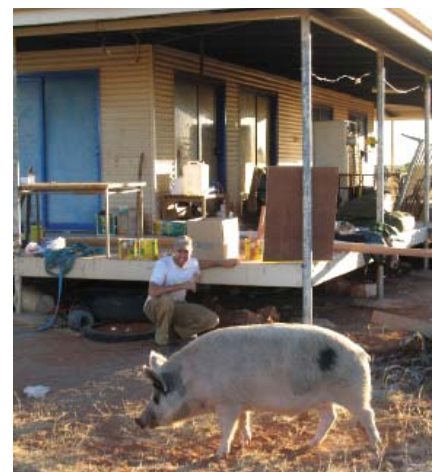
The original design and construction of these houses contributed to the poor state of the flooring:

- Floor joist spacing of 600mm is inadequate for this plywood flooring product. Spacing should be 450mm. As a consequence, the flooring was bouncy and had sagged between joists.
- No fireproof material had been placed beneath the wood heater. Holes had burned through the flooring where embers spilled from the fire box.
- External doors had no sills or cappings resulting in lifting and splitting to plywood at the entrances.
- MDF skirting boards had deteriorated significantly.

In consultation with Aramwelke Resource Centre and the traditional owners it was decided to install new flooring over the existing plywood. Aramwelke purchased the flooring and skirting materials, while ITS provided fixings, consumables, labour and transport. Termite and water resistant flooring sheets were screwed and glued to the existing flooring and cut to fit around all door and window frames.

A cement sheet substrate was fitted underneath the existing wood heaters, and new cover strips were installed to external doorways. The existing MDF skirtings were removed and replaced with solid timber skirtings, a far more durable product. The floors and skirtings were sanded and sealed with a clear water based sealer, which can easily be recoated in the future.
