Urlampe septic tank project

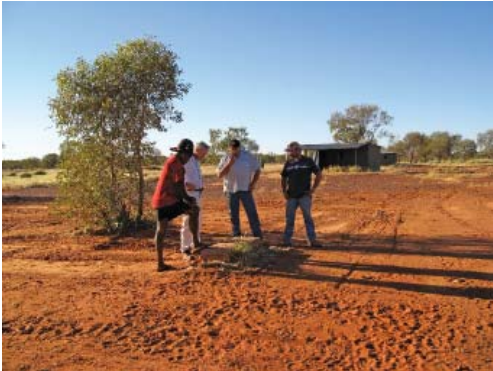
Septic tanks are often buried with no access shaft to ground level. This makes the task of exposing the septic tank for pumping-out or simply for inspecting its condition a difficult one. None of the five houses at Urlampe had cover slabs. The tanks were buried about 500mm underground, with only the inspection pipes protruding above ground.

This means that anyone trying to de-sludge the tanks would have to excavate the earth above the tank and then backfill again afterwards, a large amount of work for what should be a simple operation.

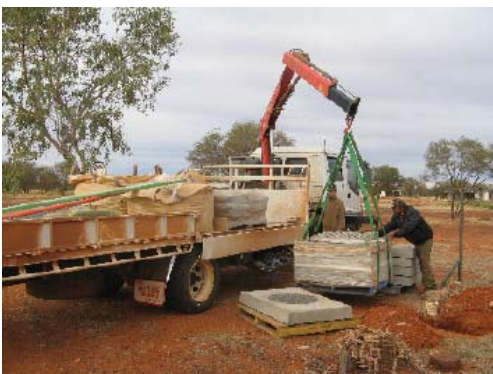
In consultation with the residents it was decided, as one part of a broader works and maintenance plan, to install coverslabs with 600mm lightweight gatic openings. The septic tanks were rectangular rather than the conventional cylindrical tanks. In place of a pre-cast saddle, two courses of concrete blockwork were laid with the coverslabs bedded onto the top course.

Each one of the lids weighed about 600kg, far too heavy for even several strong men to possibly lift. The lids were lifted and placed with the vehicle loading crane on the ITS Isuzu truck, an operation that proved extremely efficient. The exact placing of the lids was particularly important, as the lip had to be bedded exactly over the blockwork. The crane allowed precise placement while being quick enough to create a solid mortar joint.

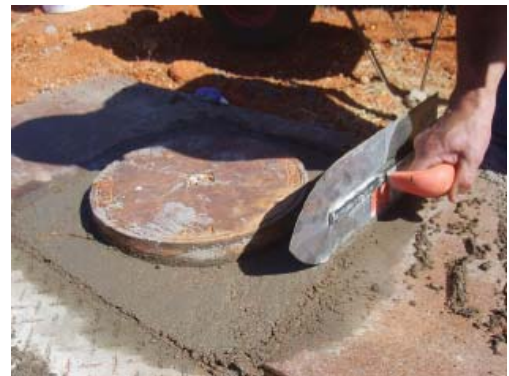
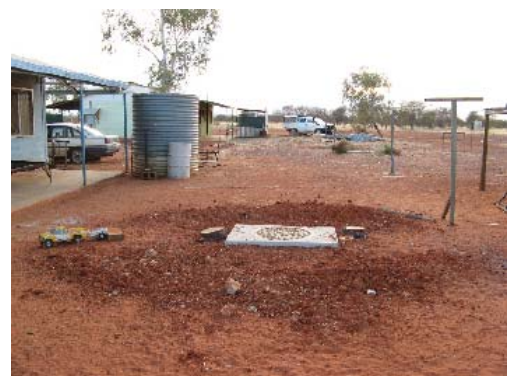
After the lids were in place and the mortar was cured, a new concrete apron was constructed around the inspection pipes adjacent to the new lid. The existing cast iron cover was reused and cast into the new in-situ apron.

This operation was completed on all five houses at Urlampe.
